Manhole Inspection Summary

Manhole # S25Q__010MH

Insp Date: **4/9/08 12:07 PM**

Location Address: **1501 BUSH ST.**

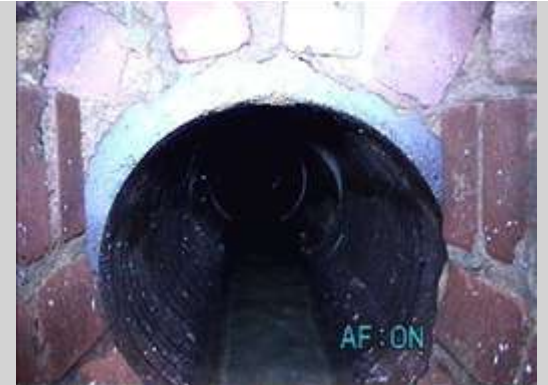
12 O'Clock Outflow

10 in. Circular Gravity Sewer
Pipe Out @ 12 O'Clock

Pipe Height: **10.8** (in.) Rod and Bar (Angled)
Pipe Material: **Clay** ☐ Pipe Lined
Invert Depth: **7.00** (ft.) Flow Characteristics: **Slow**
Deposits: ☒ None ☐ Mud ☐ Sludge ☐ Debris ☐ Grease
Silt Depth: **0** (in.) Deposits Extent:
Infiltration: **None** Pipe Seal Cond: **Sound**

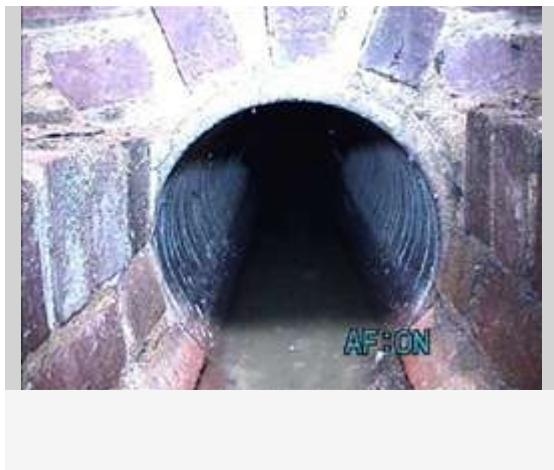
6 O'Clock Inflow

10 in. Circular Gravity Sewer
Pipe In @ 6 O'Clock

Pipe Height: **10.8** (in.) Rod and Bar (Angled)

Infiltration: **None** Pipe Seal Cond: **Sound**
